Assessing Green Roof Accessibility for the Disabled Community in High-Rise Residential Buildings

Abstract

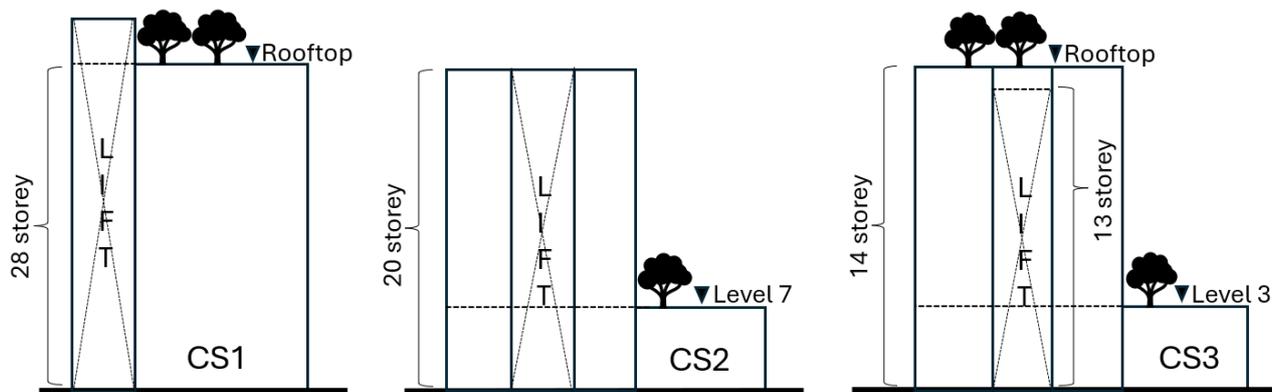
**Figure 1.** Diagrammatic green roof location at CS1, CS2 and CS3 (from left to right)

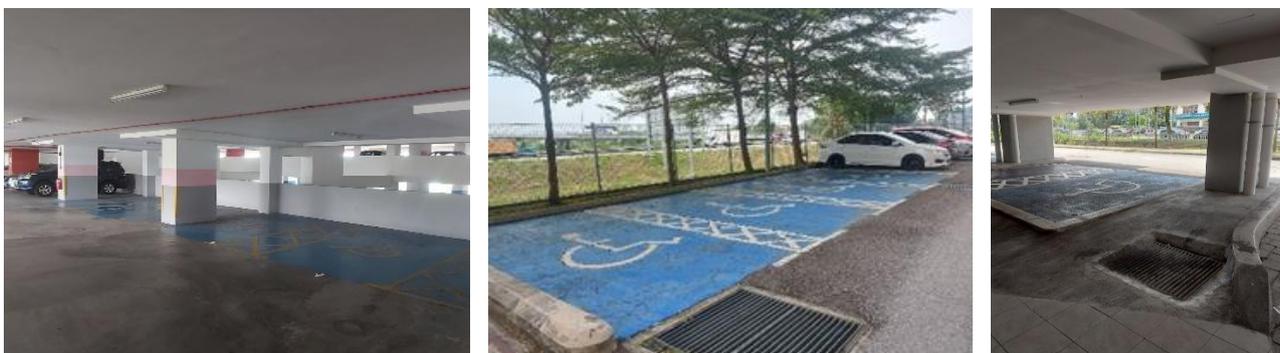
The access audit revealed that while accessible parking is provided in all three case studies, the dimensions of these spaces are insufficient for larger vehicles like those equipped with hydraulic wheelchair lifts. According to the audit, the parking sizes range from 3200mm x 4800mm to 4500mm x 4900mm, which may be sufficient for standard vehicles but inadequate for longer vehicles like vans with hydraulic wheelchair lifts. To accommodate such vehicles, the recommended size for an accessible parking bay should be at least 3600mm x 5400mm. This dimension provides additional length compared to the minimum 4800 mm, accommodating larger or accessible vehicles such as vans.

Additionally, Figure 2 shows the absence of standing signage to clearly mark accessible parking spots increases confusion, making it harder for disabled drivers to locate designated areas. This highlights the need for clearer identification and appropriately sized parking spaces to meet the accessibility needs of all users.

Figure 2. Accessible parking space at CS1, CS2 and CS3 but lack standing signage (from left to right)

To enhance accessibility in line with MS 1184:2014, green roofs in high-rise residential buildings should include parking bays measuring at least 3600 mm x 5400 mm with clear vertical signage. Entrances should be fitted with automatic doors, and ramps must not exceed a 1:12 gradient. Lift emergency buttons should be positioned between 900–1200 mm, and lift access must reach all levels. Pathways should be smooth and slip-resistant, while signage must be clear and at accessible heights. Communal areas must provide adequate knee clearance and reachable fixtures, and accessible toilets should include emergency intercoms and remain unlocked. Ramps and widened doorways are also essential for accessing all amenities. These improvements ensure compliance and promote inclusive use of green roofs.

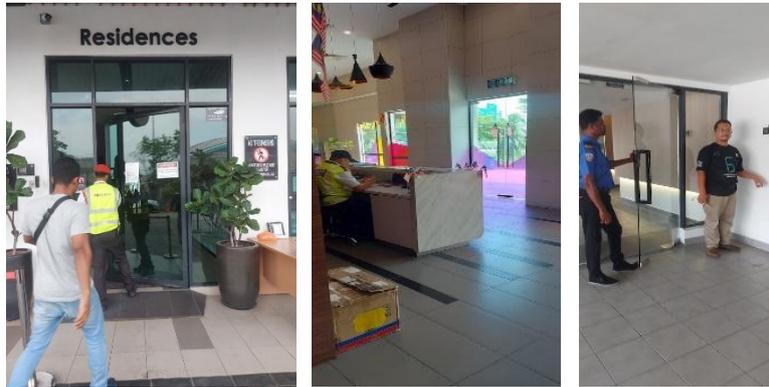
Manual doors in all three case studies pose significant challenges for the disabled community, particularly those with mobility difficulties, as they require considerable force to open. This limits independent use and increases reliance on assistance. Kadir and Jamaludin (2012) highlight the role of automatic doors in promoting independence by reducing physical effort, aligning with universal design principles that prioritize accessibility for all users.

Figure 3. Main entrances at CS1, CS2 and CS3 with security assistance (from left to right)

The access audit reveals that while the main entrances meet the minimum width requirement of 900mm, none of the case studies provide automatic doors. Although each case study offers some security assistance, this does not fully resolve the accessibility challenges posed by manual doors. MS 1184:2014 recommends installing automatic or power-assisted doors to enhance accessibility and support independent access.

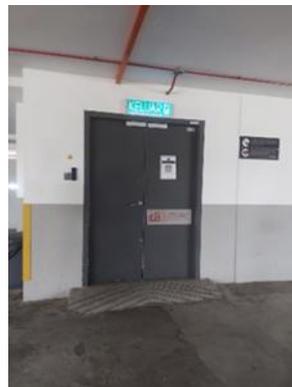
Figure 4. Steep ramp in front of entrance in multi-level parking in CS1

Figure 4 shows the entrance from the multi-level parking in CS1, which features a manual door with a lever. However, there is a steep ramp located directly in front of the door, which poses a challenge for wheelchair users, and no security personnel were observed to assist with access.

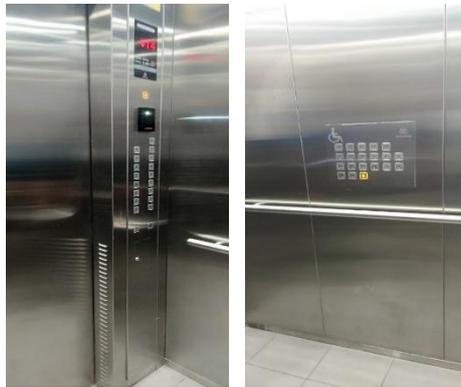
In the case of lifts, although they generally meet width and internal space requirements, the placement of emergency buttons in some instances exceeds the accessible height range, limiting usability for wheelchair users. According to the audit, while the lift door dimensions comply with the minimum width requirement of 900mm and the internal size of 1400mm x 1400mm, the emergency intercom button in CS2 is positioned at

1400mm, making it difficult for wheelchair users to reach. Kadir and Jamaludin (2012) raised similar concerns in their study, emphasizing that the improper placement of controls and emergency systems in public facilities often creates barriers to accessibility. Ensuring that these critical components are within an accessible height range (between 900mm and 1200mm from the floor) is vital for enhancing the usability and safety of lifts for the disabled community.

In contrast, CS3 provides a good example by including a separate panel designed specifically for wheelchair users and children, ensuring that the controls are easy to reach and improving accessibility for all users.

Figure 5. Vertical button panel for typical users (left); horizontal button panel for the lower-reach users (right)

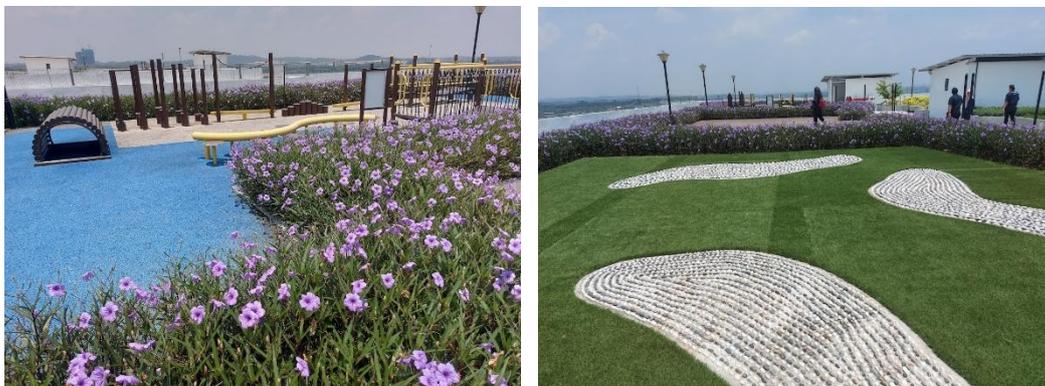
The absence of lift access to rooftop areas, as observed in CS3, creates a major barrier to accessing recreation area at the green roof (Figure 6), requiring users to climb stairs. This reflects a broader issue highlighted in the study where vertical circulation frequently fails to meet MS 1184:2014, restricting access for mobility-challenged users. As noted, such inaccessibility not only limits physical access but also reinforces social exclusion, turning green roofs into spaces of inequality (Archer, 2013).

Figure 6. Inaccessible recreational area at the rooftop of CS3, where users need to climb stairs to reach to this level

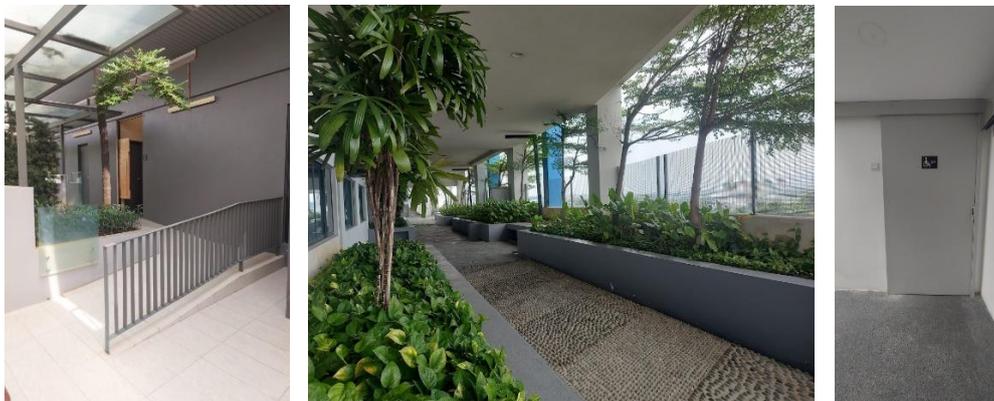
All pathway widths exceed the minimum requirement. However, none of the case studies meet the MS 1184:2014 standard of a 1:12 gradient for ramps, creating a significant challenge for wheelchair users. In CS1, the audit reveals that the ramp in front of the lift leading to the green roof space has a gradient ratio of 1:8, which exceeds the allowable gradient, making it steeper than recommended. Similarly, in CS2, a 1:6 gradient ramp is used, and despite its textured surface designed to prevent slipping, the steepness remains problematic for wheelchair users. CS3 also features a ramp with a gradient of 1:9, further limiting accessibility to certain areas. One of the best ramp examples in CS1 is the L-shaped ramp in front of the toilet, with a gradient ratio ranging from 1:9, 1:8, to 1:10 as shown in Figure 7.

In addition to the non-compliant ramps, uneven surfaces, such as pebbled pathways in CS2, present impaired accessibility issues for wheelchair users. The pebbled pathways may serve aesthetic purposes but compromise usability; a concern echoed by Mesimäki et al. (2019) and Rahman et al. (2023), who stress the need for designs that balance well-being and functionality. Pathways should ideally be smooth and stable to provide easier movement for wheelchair users and those using mobility aids. Moreover, while signage was present at all the case studies, it lacked clear directional indicators, making navigation challenging for users unfamiliar with the space.

Figure 7. L-shaped ramp in CS1; pebbled pathways in CS2; signage provided at the toilet facility without directional indicators in CS3 (from left to right)

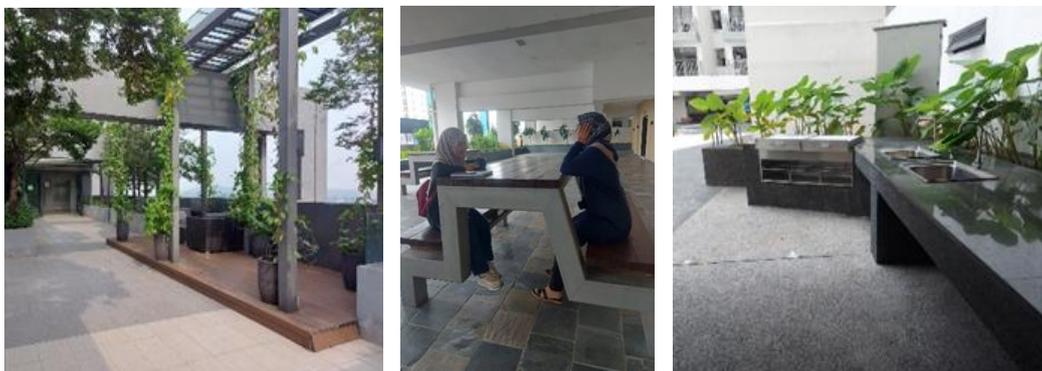
The analysis of seating areas and the barbecue facility across the three case studies reveals several accessibility challenges. In CS1, seating areas are inaccessible due to wooden decks lacking ramps, preventing wheelchair users from accessing these spaces. CS2 presents impractical seating arrangements, with tables and benches too high for wheelchair users and even uncomfortable for non-disabled individuals. CS3, while providing accessible seating on Level 3, still has issues with the barbecue facility.

Figure 8. Wooden decking lacks of ramp in CS1; impractical bench and table height in CS2; insufficient knee clearance for the hand basin, and the faucet handle is beyond reach in CS3 (from left to right)

In all case studies, while the barbecue areas comply with standard hand basin height, none provide adequate knee space, limiting usability for wheelchair users. CS1 lacks knee clearance entirely, while CS2 and CS3 have additional issues such as unreachable faucet handles and, in CS2, a shallow, uncovered drain that further complicates access. These inconsistencies dilute the potential of green roofs as shared social spaces and mirror what Frías-López & Queipo-de-Llano (2020) call a lack of ‘reasonable adjustments’ in public design.

These findings suggest that while there is some adherence to accessibility standards, the designs fail to meet the functional needs of wheelchair users. Adding adequate knee clearance, ensuring faucet handles are within reach, and addressing seating height would make these communal spaces more inclusive, supporting compliance with MS 1184:2014.

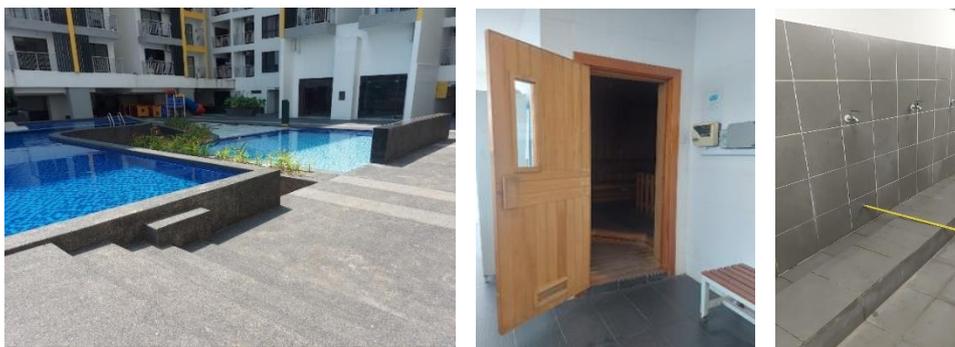
The accessibility of amenities such as swimming pools, saunas, and prayer rooms varies across the case studies. In CS3, the absence of ramps prevents access to the swimming pool, which excludes wheelchair users from recreational spaces. This aligns with the findings of Rahman et al. (2023), who emphasize that accessible design of green roofs is essential for enhancing inclusivity and well-being for all users. Additionally, both CS1 and CS2 present barriers to sauna access due to high curbs and narrow doorways, while in CS3, the water tap in the ablution area is difficult to reach.

Figure 9. Steps at the swimming pool area in CS3; inaccessible sauna entrance in CS2; inaccessible water taps in the ablution area in CS3 (from left to right)
